## SITUATION

NASA ATLANTIS SPACE SHUTTLE

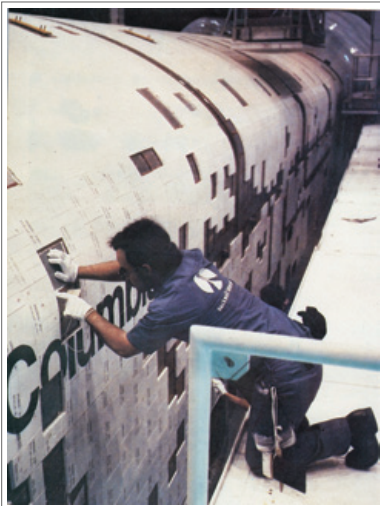
OVER 40,000 UNIQUE TILES

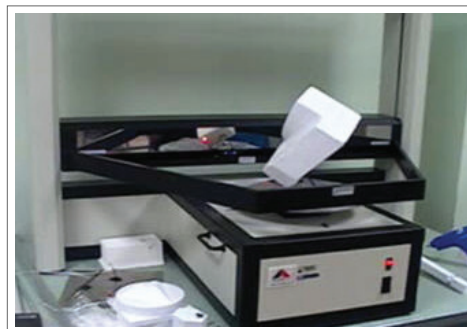
CUSTOM TILE SCANNING SYSTEM

3DScanCo developed a custom scanning system that fully automated the tile repair and fabrication process. The custom scanner uses a turntable to accurately scan and generate point cloud data for the tiles, which are then auto-surfaced using NURBS surfaces. The resulting CAD data is then used to machine an exact copy of the tile for replacement on the shuttle.
